PIPE BURSTING WATER LINES IN LIMITED ACCESS LOCATIONS

by Thomas A. Harris, P.E.
Meran Dadgostar, P.E.

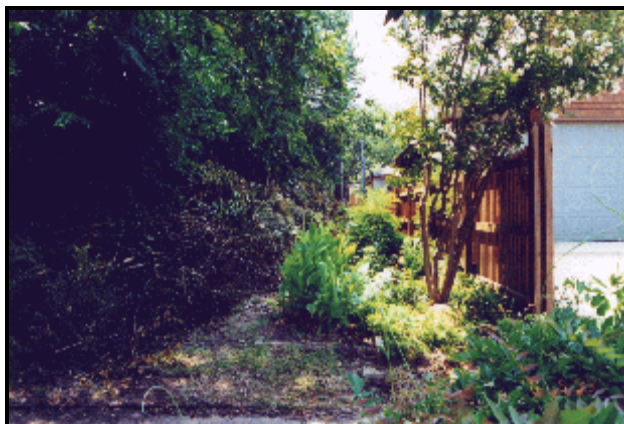
Figure 2 - Easements in the project location were overgrown and congested with utilities

Earlier construction in similar easements using open cut methods resulted in high construction costs and lengthy, disruptive construction periods. In other areas of the Town, trenchless technology has been used successfully to replace sewer lines. Why not consider using the same technology to replace the water? The Town believed if the contractor were to replace the water using trenchless methods, the disruption would be minimal, and access would be less of a factor in

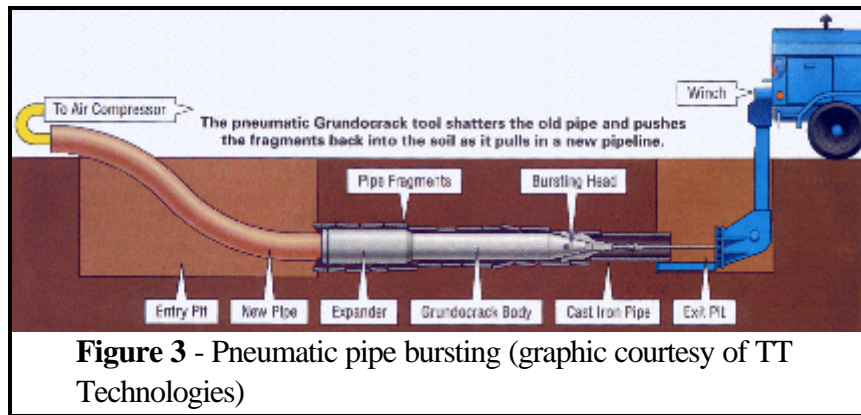
The hydraulic process, as with the pneumatic process, requires a launch and exit pit. The hydraulic equipment is placed in the exit pit, and guide rods are assembled and pushed through the host pipe to the launch pit. The bursting head, expander, and new HDPE pipe are attached to the guide rods. The assembly is then pulled through the host pipe, crushing it into the surrounding soil.

The pneumatic bursting process is similar to hydraulic, except the bursting tool hammers the host pipe, fracturing it. The fragments are pushed into the soil as the tool progresses through the pipe. A cable is attached to the bursting tool that runs through the host pipe to a winch at the exit pit. Tension is kept on the cable during the bursting process, and serves mainly to guide the tool. The pneumatic tool, depending on soil conditions, size and type of pipe, and how much “upsizing” is required, is capable of bursting pipe segments greater than 700 feet.

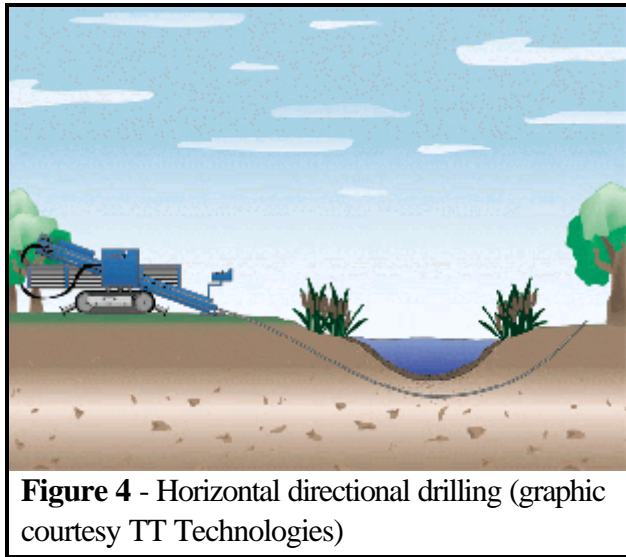
Figure 4 - Horizontal directional drilling (graphic courtesy TT Technologies)

HDD is a two step process. First, a pilot bore is made where the conduit will be placed. The drill head is equipped with a transmitter that generates a magnetic field that is interpreted by a receiver as depth and direction. This technology tracks the vertical and horizontal location of the drill as it progresses from the entrance to the exit location. Second, a drill large enough to accommodate the pipe to be installed is pulled back through the pilot bore. The conduit is attached to the drill and pulled behind it as it is withdrawn from the original entrance location.

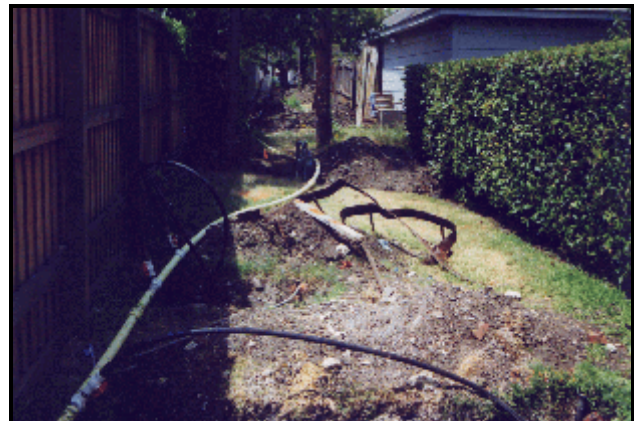
Figure 5 - Temporary water lines could meander within easements

replacement. Certainteed “Certa-Lok” 2-inch PVC pipe was used for the temporary water lines. Since there would be no large excavating equipment needed in the easements, the temporary water lines could

be installed above ground without concern that they would conflict with construction activities. The existing water line was approximately 3.5 feet below grade, so access pits at the service connections were excavated by hand. Once the temporary lines were cleaned and tested, the line was pressured, and the residential services were connected.

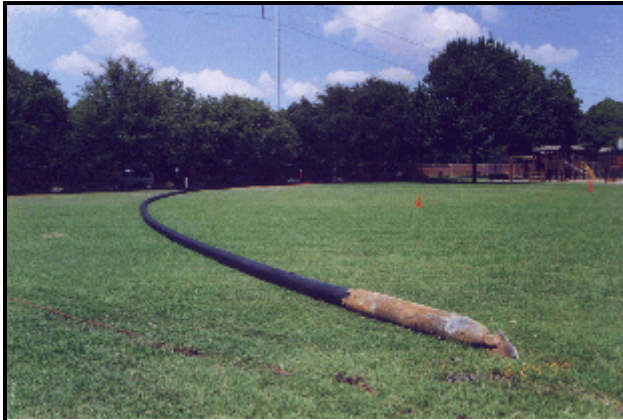
Figure 6 - Town park was available for equipment staging

DR-14 was specified for the replacement pipe; welded together to provide a continuous conduit for the entire length of pipe to be replaced. A Town park was available as the staging area for the new HDPE. Were this not possible, the pipe is flexible enough that it could have been placed along the curb line of the adjacent streets. Once the HDPE was attached to the bursting tool and in place, a cable was strung through the old pipe that connected the bursting tool to the winch at the exit pit. Bursting began, and the tool progressed at approximately three feet per minute. The entire bursting operation was completed without encountering any significant problems in four hours.

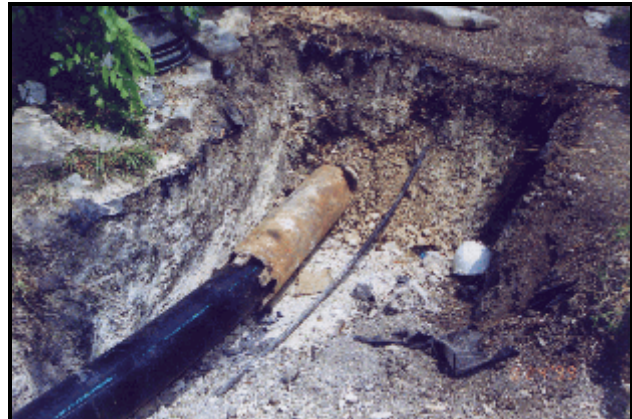
Figure 7 - Insertion pits were approximately 10' x 6'

Insertion and exit pits for the bursting equipment were constructed at the ends of the easements where access was not restricted. Although there was plenty of room for the pits, an area only ten feet long and six feet wide was necessary for each pit. High Density Polyethylene Pipe (HDPE)

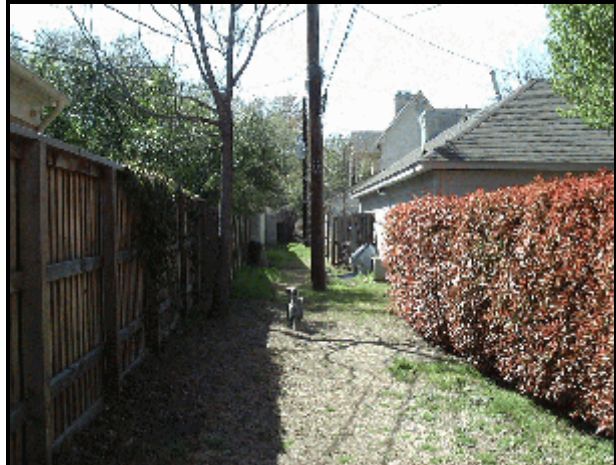
Figure 8 - Completed project - water and sewer replaced in easements with minimal disruption to citizens

After a “good” lab report was received, the new main was connected to the existing water main, and services changed over from the temporary water line. Access pits and service tie locations were covered, and the easement graded and sodded. The entire installation was completed in fifteen working days, exclusive of lab testing. Noise from the bursting equipment lasted for only four hours, as compared to a similar open cut project where over five weeks of equipment movement took place within the easement. Not only was noise pollution reduced, but there was no trench spoil to store, and no embedment to truck into the easement. The result; minimal citizen complaints during the construction period -- a welcome outcome on any project. The cost to the Town of Highland Park for clearing the easements, installing the new main with all appurtenances, grading and sodding was \$103 per foot. This represented a savings of nearly 30 percent over previous open cut replacement in a similar area.
